Species, Grading, and Mechanical Properties of Locally Sourced Timber¹ in the Joyabaj Region of Guatemala

ABSTRACT: *The purpose of this project was to research the timber used by Engineers Without Borders (EWB) groups in the Joyabaj region of Guatemala. This project aimed to investigate the species of wood, evaluate the quality by assessing the distribution of timber grades, and determine mechanical properties. The results will aid EWB groups in the design of wood structures in the Joyabaj region of Guatemala. Samples were collected for species investigation and mechanical testing. Species investigation was triangulated from interviews with the sawmill owner, construction foreman, testing by the USDA Forest Products Laboratory, and comparisons to literature. The results were inconclusive and indicated multiple species were intermixed at the sawmill with no distinction made when purchased. Timber quality was evaluated by using a visual grading guide developed by the authors to assess the distribution of grades within a large order of lumber. Static bending and compression parallel to grain tests were conducted to obtain modulus of rupture, compression parallel to grain, and modulu

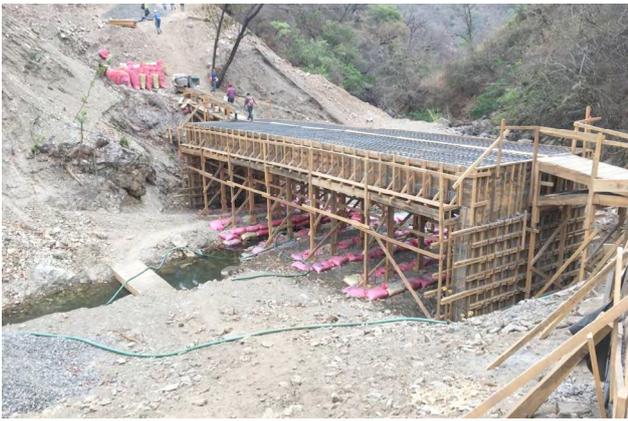
Figure 1: Formwork for the Aguacate II Vehicular Bridge in Joyabaj, Guatemala using locally sourced timber

The construction of these bridges requires significant amounts of locally sourced timber for formwork (Figure 1).

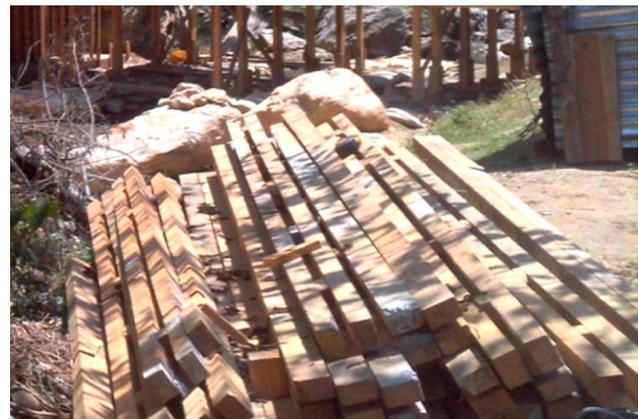
Figure 3 (bottom): Portion of the lumber graded in this research project

To evaluate the distribution of grades in the timber provided by the sawmill, the Visual Grading Guide was field tested by one of the authors on 509 pieces of timber for use as forming for a vehicular bridge (Figure 3). Timber sizes are described in standard North American dimensional timber units that are nominal cross-section dimensions in inches. All the 2 x 4s, 2 x 6s, and 4 x 4s were evaluated, but only a portion of the 2 x 3s and 1 x 12s

were evaluated due to time constraints. Timber was taken from various parts of each pile to ensure randomness. Each piece was numbered, photographed, and measured. All four sides were inspected. The size and soundness of knots were recorded, the presence of decay, warp, wane, split, shake, compression, and checks were also noted for evaluation. Some defects such as sloping grain, compression failure, and checks were not assessed due to the roughness of the cut and the dirt that covered them. Warp was measured on obviously warped pieces by comparing to a flat surface.

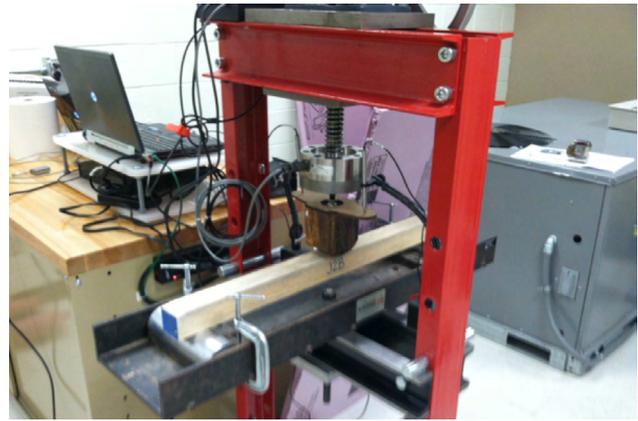
Figure 4 (top): Static bending test

The static bending tests (Figure 4) were performed on sixteen 50 mm x 50 mm x 762 mm (2" x 2" x 30") specimens centre-loaded in bending by a bearing block with supports 710 mm (28") apart. The specimens were loaded until failure and the test results used to determine the modulus of rupture (MOR).

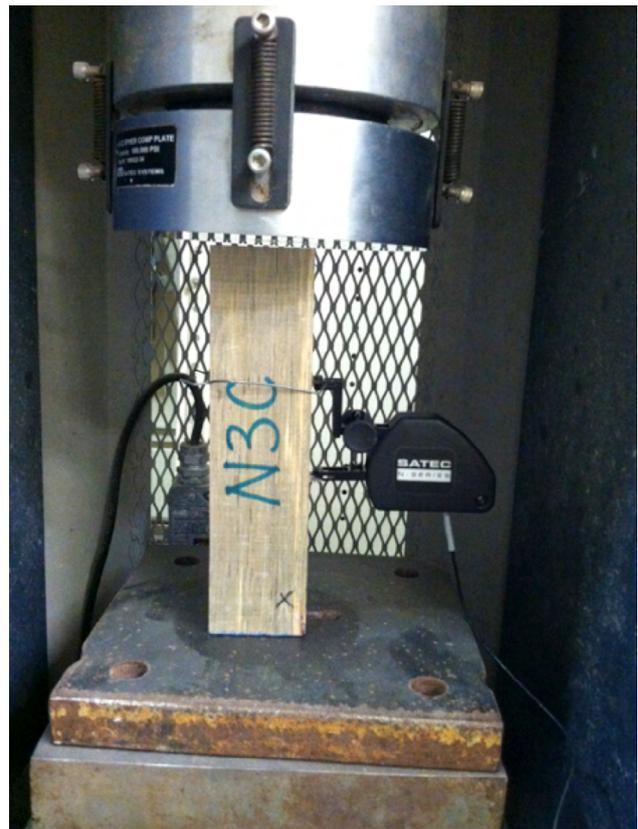
Figure 5 (bottom): Compression parallel to grain test

The compression parallel to grain tests (Figure 5) were performed on twenty-four 50 mm x 50 mm x 205 mm (2" x 2" x 8") specimens loaded axially in compression along the long axis. The specimens were loaded until failure and the test results used to determine the compression parallel to grain (F_c) and modulus of elasticity (E). The equipment measuring axial strain malfunctioned such that modulus of elasticity (E) was not able to be obtained.

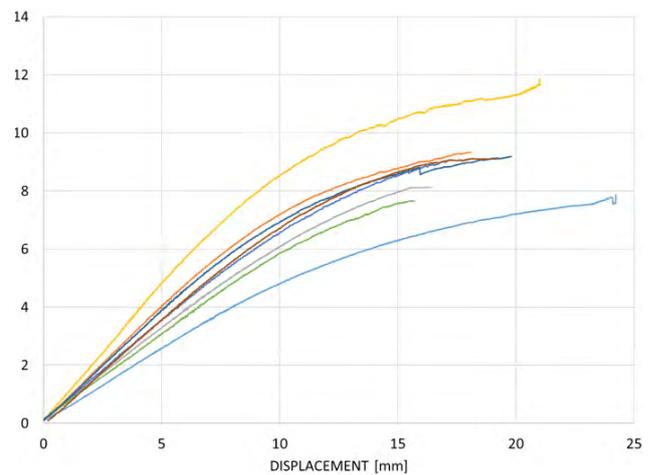
Figure 6 (top): Load versus displacement results for static bending tests for Trip A samples

The test results for each sample set are presented in Table 3 to Table 6. The load versus displacement graphs for the static bending tests for Trips A to C are presented in

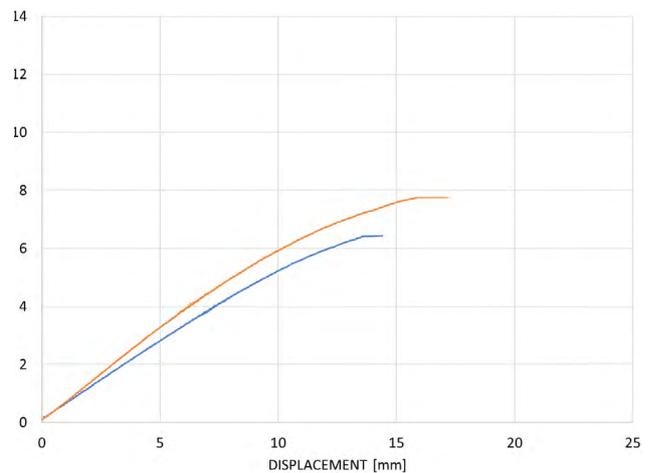
Figure 7 (bottom): Load versus displacement results for static bending tests for Trip B samples

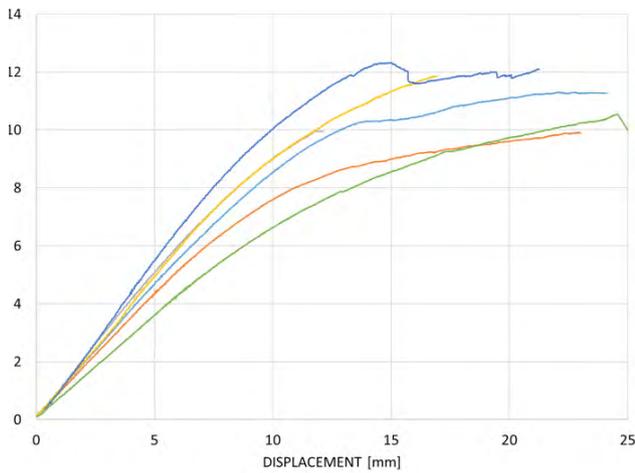
Figure 8 (top): Load versus displacement results for static bending tests for Trip C samples

Figure 6 to Figure 8 respectively. The load versus displacement graphs for the compression parallel to grain tests for Trips A to C are presented in Figure 9 to Figure 11 respectively.

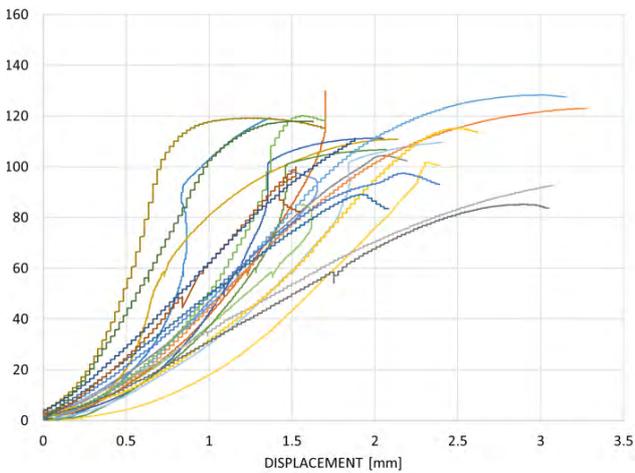
Figure 9 (upper middle): Load versus displacement results for compression parallel to grain tests for Trip A samples

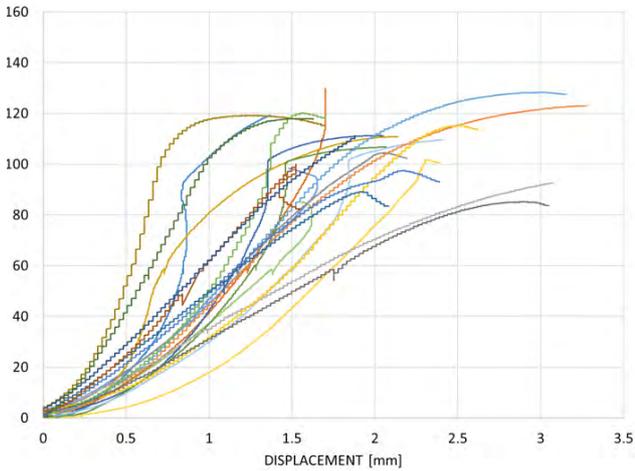
Figure 11 (bottom): Load versus displacement results for compression parallel to grain tests for Trip C samples
