Partnership to Improve the Quality of Local Construction Materials in Haiti's Central Plateau

ABSTRACT: *This paper presents a successful ongoing partnership between Clemson Engineers for Developing Countries (CEDC) and a concrete masonry unit (CMU) manufacturing plant in rural Haiti. The infrastructure destruction and resulting loss of life of the 2010 earthquake in Haiti highlighted the need for improved building materials and codes. This partnership has helped to improve the strength of CMUs in the plant, both creating a safer local built environment and expanding the economic opportunities for this plant. Using samples of aggregate and cement from the site in Haiti, students in Clemson performed experiments to optimise the CMU mix design and made other suggestions to improve efficiency and quality of their product. Consistency continues to be a challenge for the CMU plant, and this paper also describes proposed procedures to help the plant implement quality control and quality assurance plans.*

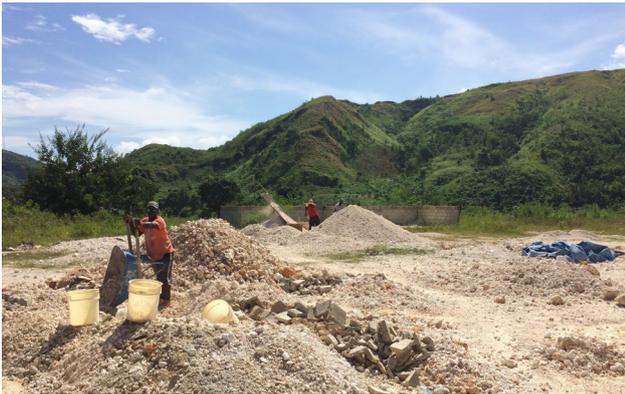
Top to bottom:
 Figure 1. Clemson engineering students with CMU plant employees
 Figure 2. The quarry where aggregate and sand are excavated
 Figure 3: Process flow diagram of CMU manufacturing plant in Haiti
 Figure 4: An employee sieving aggregate with a shovel

The Domond CMU plant works on a project-by-project basis, selling various types of blocks to constructors and contractors around the Central Plateau. They have several teams of workers around their factory. One team works at a nearby quarry (see Figure 2), excavating aggregate and sand and then transporting it to their main facility.

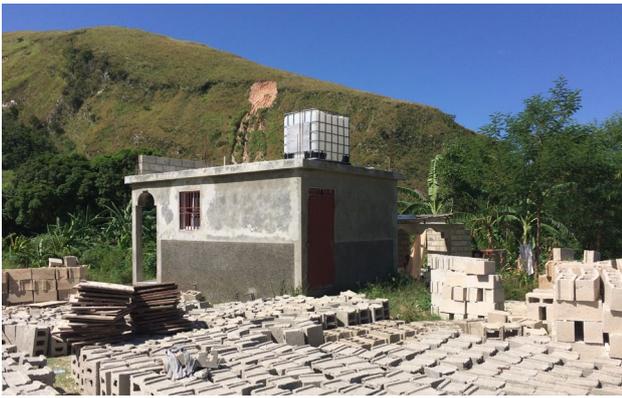
Figure 5: Manufactured CMUs curing outside

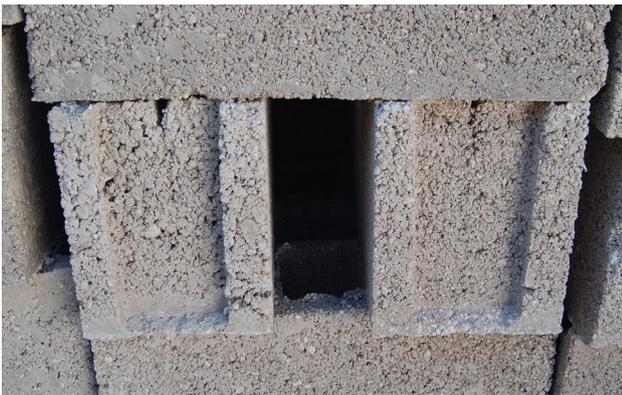
Figure 6: A photo of CMUs prior to the partnership with CEDC

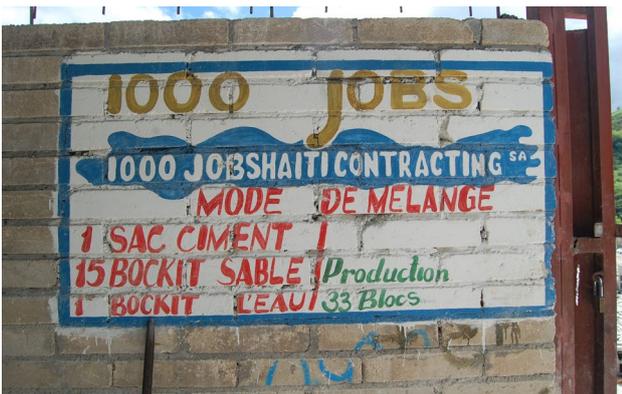
Figure 7: The mix design painted on a wall at the CMU plant

into its form. The mix design was roughly converted to units of buckets and litres so that Haitian labourers could easily measure cement, sand, and water quantities with readily available five-gallon (~19 L) buckets and water bottles. This mix design was subsequently introduced to the owners of the CMU plant in March 2013 during the CEDC Spring Break trip. The block owners then painted this mix design on the side of their plant for all their labourers and workers to use as a reference, as seen in Figure 7. This mix design calls for one bag of cement, fifteen buckets of aggregate (sand and gravel), and one bucket of water for each batch of thirty-three blocks.

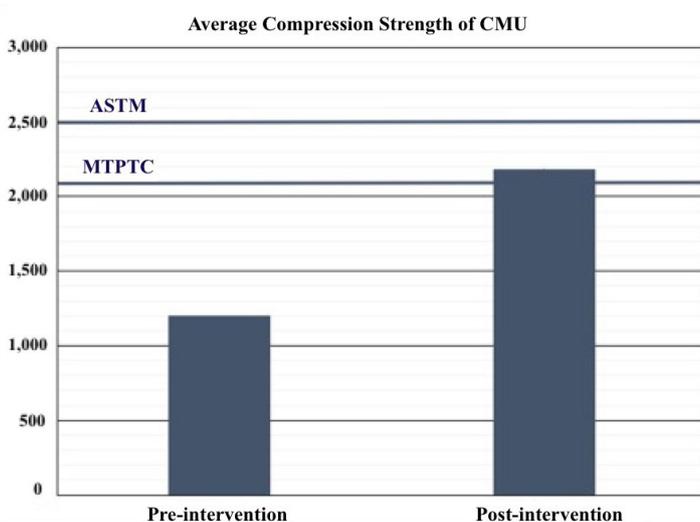
Figure 8: Average compression strength of CMU

Prior to the updated mix design, the compressive strength of the CMUs was estimated at a maximum of 1,200 psi (8274 kPa), according to compressive strength measurements by the block plant owner, using a compression machine at a local trade school. Although the pre- and post-intervention blocks were tested at different facilities, the change in compressive strength is substantial. Figure 8 provides a comparison of the averages of our testing pre- and post- CEDC intervention and also shows ASTM and MTPTC standards for CMU compressive strength.

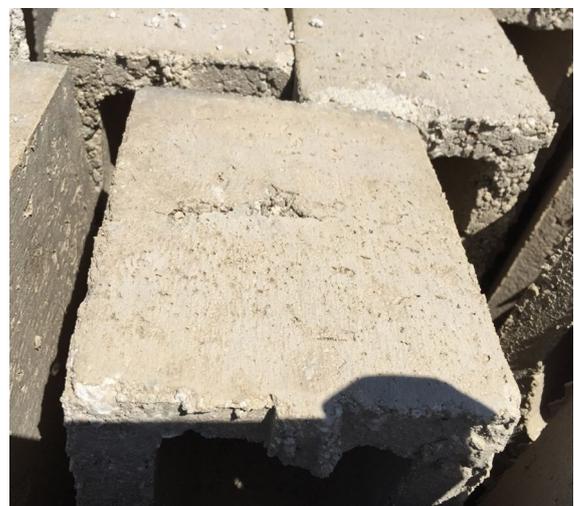
Figure 9: A photo of CMUs currently produced by the plant

While this significant increase in CMU strength is an important accomplishment, the consistency of CMU strength is just as critical. One of the CMUs brought back to the lab did not meet the strength requirement due to issues with honeycombing, indicating that the problem was likely with production techniques. Figure 9 shows CMU blocks manufactured at the plant in November 2015. These CMUs exhibit far less honeycombing and other structural integrity issues than block manufactured prior to the CEDC partnership, seen in Figure 6. Honeycombing is still a problem at the facility, but this can be attributed to the fact that the workers at the plant deviate from mix design procedure at times.
